# Inactive Mine Site Field Form

**Project:** Animas Forks

**ID:** PG2

**Claim Name:** Clarence

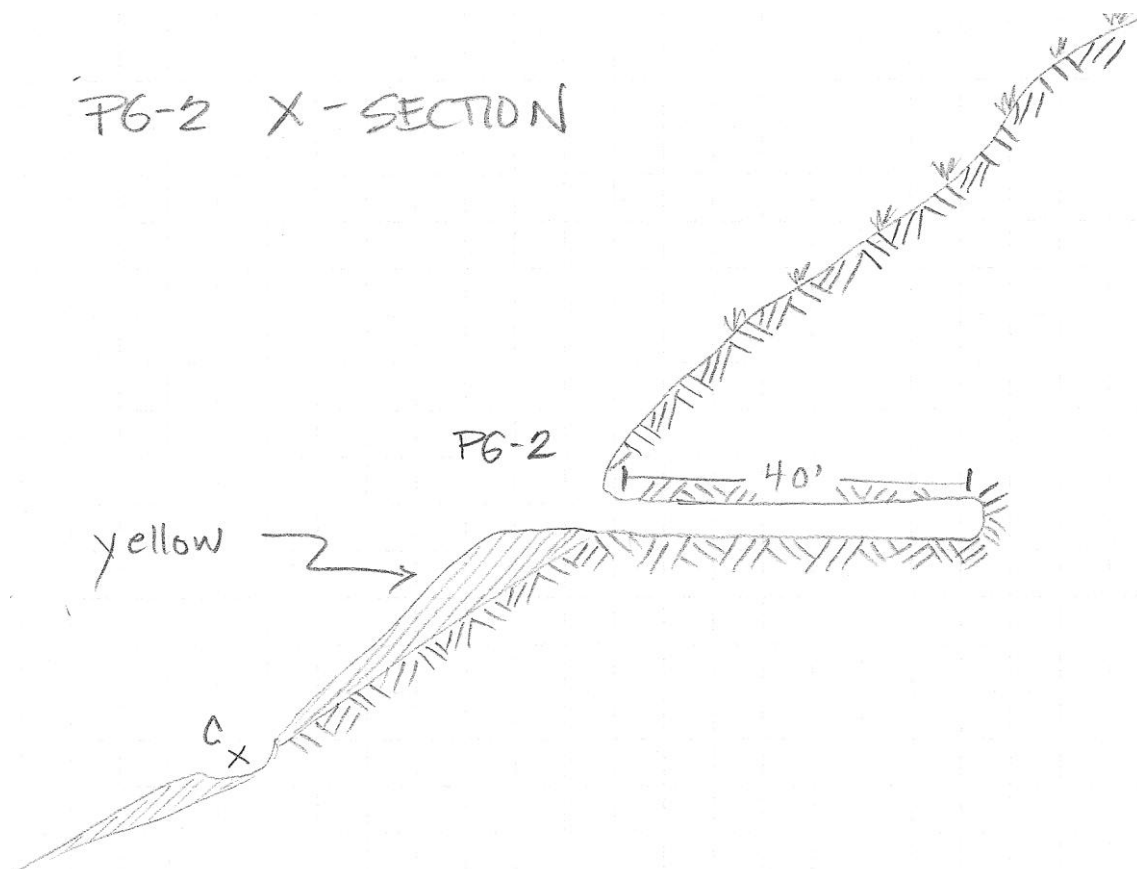
**Field Description:** On the north side of the drainage above PG1, yellow mine dump.

**Type of Feature:** Adit

**Condition:** Intact

**Shape of Opening:** Arched

**Work Description:** Bulkhead per SWS 14. All necessary rock material is located on-site.
